# Manhole Inspection Summary

Manhole # S35KK\_014MH

Insp Date: **3/9/07 1:58 PM**

**Location** Address: **209 MCALLISTER ST**

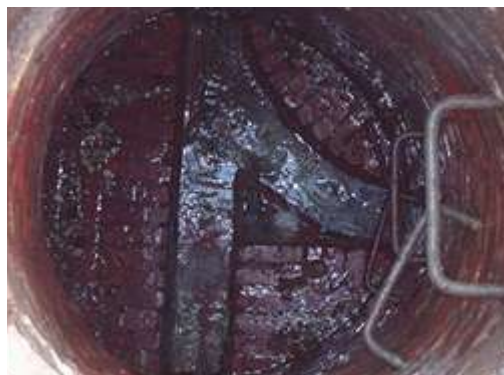
Top View

☒ **Debris** (not Condition related)

Count: **5** Missing: **0** ☒ **Corroded**

Corroded steps. Bench debris.

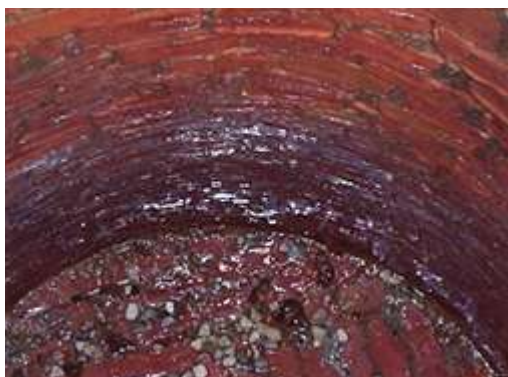
Defect

Infiltration: ☐ None ☐ Joint ☐ Cracks ☐ Mortar ☐ Roots ☒ **Wall**

Barrel infiltration.

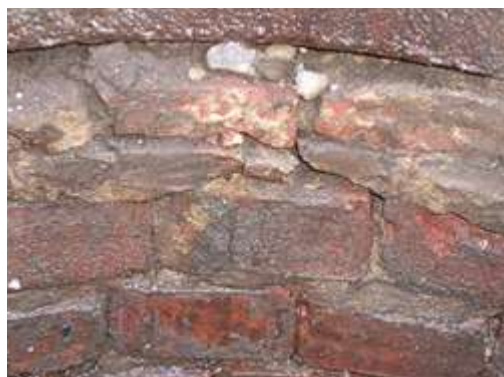
Defect

Condition: ☐ Sound ☐ Cracked ☐ Root Intrusion ☐ Loose Brick ☒ **Deteriorated**

Infiltration: ☐ None ☒ **Joint** ☐ Cracks ☐ Mortar ☐ Roots ☒ **Wall**

Adjustment deterioration and infiltration.

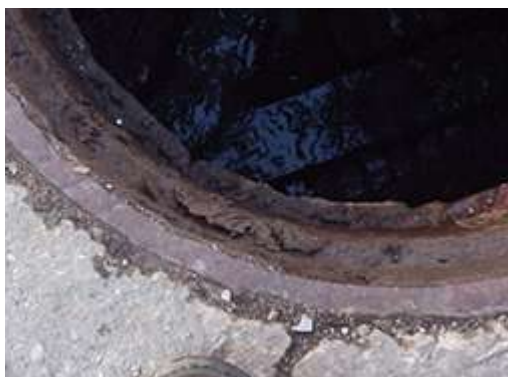
Defect

Offset: **1** (in.)

☒ **Leaks**

Frame leaks. Frame offset.

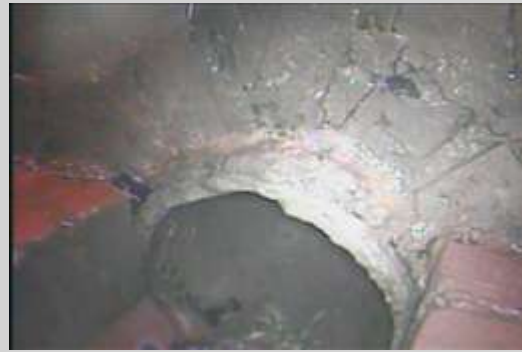
Drop In @ 6 O'Clock

Drop Condition: **Partly Clogged**
